## ANOTHER 'WORKSHOP' AT MURRAY'S GARAGE

# The DeSoto Guys Are At It Again!

The reason for the workshop was to get to the bottom of a shifting problem that has plagued the DeSoto club's Activity Director, Bob Baer's 1948 DeSoto DeLuxe two-door sedan since he has owned the car.

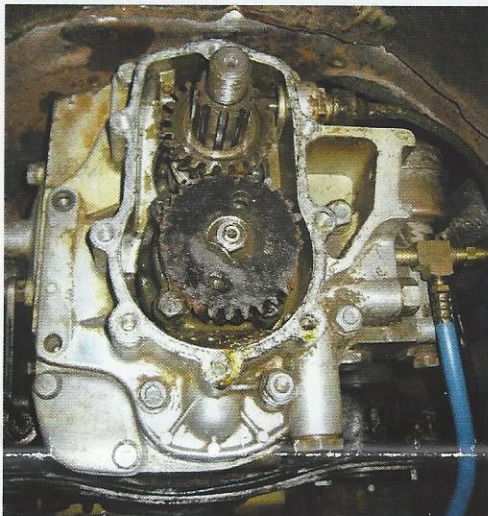
In the picture above, the lower 'fibrous' gear is badly 'chewed' up and is causing 'zero' hydraulic pressure to make shifts properly. The blue hose is attached to a gauge to test pressure during shifts. Murray Cole 'jabbed up' a unique connector to fit the port on the transmission for the hose.

One of the gears was a fibrous gear and it was completely shot. Most of the teeth were missing. This is the oil pump drive gear. We hand-rotated the oil pump shaft and oil gurgled, we suspected the oil pump was okay. Bob removed the same gear from the spare transmission on the bench that was in perfect condition, put it into the gearset in the DeSoto; repeated the fluid pressure test and bam! Fifty psi on the gauge!
